Rail Tank Cars show a mere 0.044% Coating Loss over 7 years in Sodium Bisulfite service with ChemLINE®

The story of Southern Ionics' ChemLINE® Application

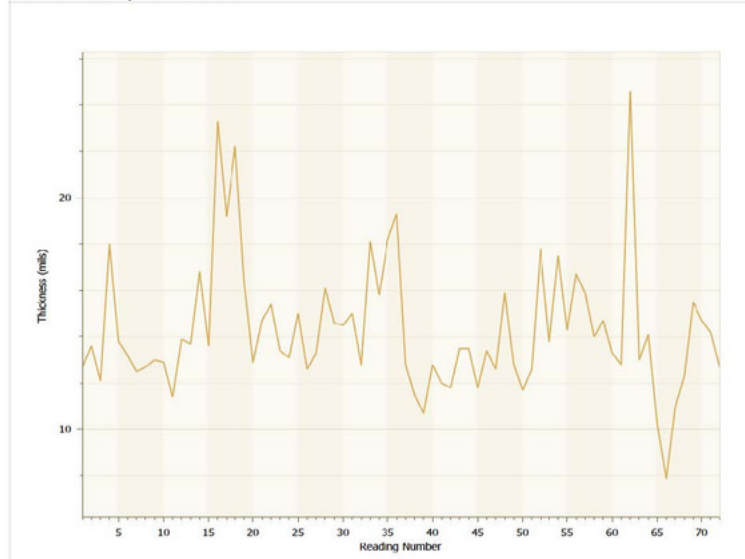
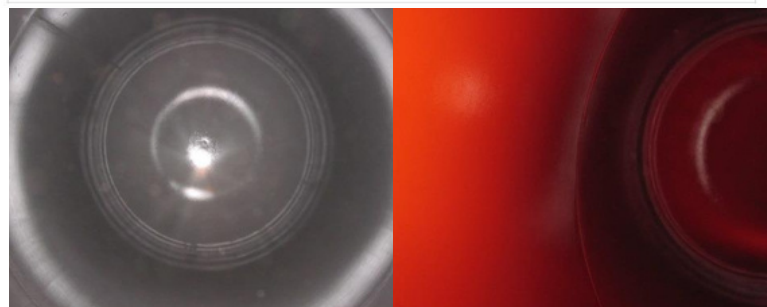
Individuals / Run Chart

The tanks were then forced hot air-cured at a low temperature of 250°F and, within a few days, were put back into service. APC technical team was present for the application process and performed the first post-application inspection. APC's Technical Service Manager, Joe Fortman, recorded the DFT readings presented in the chart to the right.

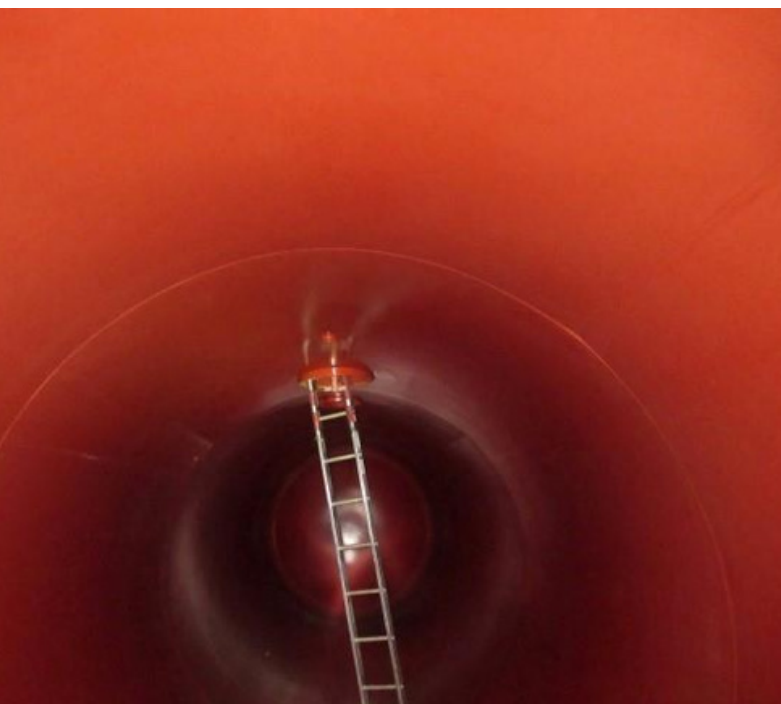
These same two rail tank cars were brought in for a field inspection in August 2018, again with APC inspectors onsite. The tank cars showed minimal corrosion around the manway, as expected.

Still, the barrel of the tank car showed excellent coating condition, and the coating maintained a significant amount of gloss, as pictured left.

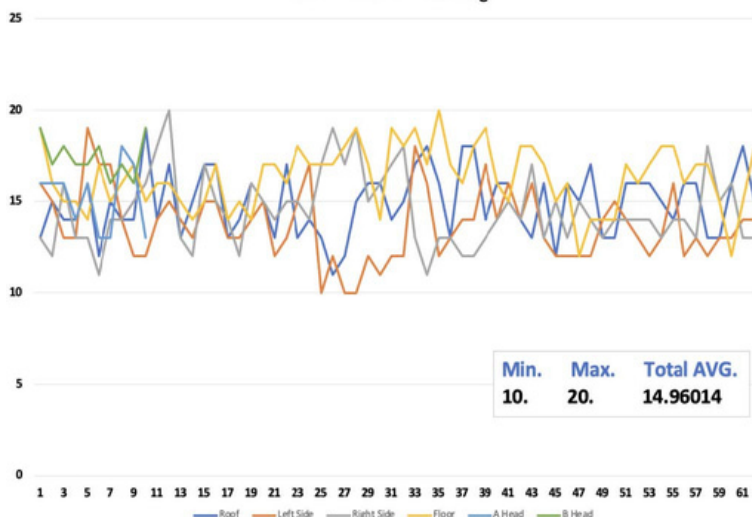
Rail Tank Car DFT Readings

APC Inspector Fortman took DFT readings of the coating, which boasted an outstanding **0.044% coating loss over the seven years** the cars had been utilized in the Sodium Bisulfite service.
